G. Dube, P. Pistorius, D. Simon, N. Xaba, R. Koenis , N. Dowling

UNEXPECTED MECHANISM OF CRUDE OIL HEATER CONVECTION SECTION FAILURES

G. Dube	Shell and BP Refineries
P. Pistorius	MEGCHEM
D. Simon	Shell Company of Australia
N. Xaba	Shell and BP Refineries
R. Koenis	MEGCHEM
N. Dowling	Shell and BP Refineries

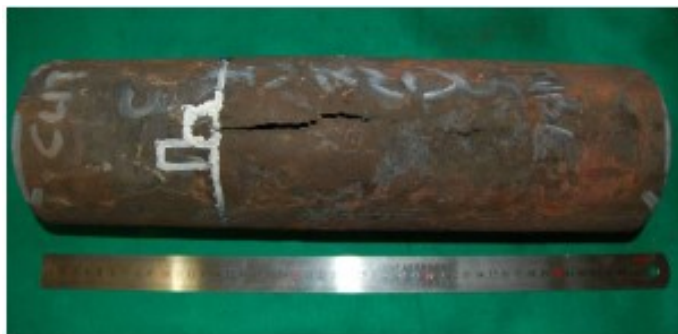
Initial observation of both convection sections showed clearly that the failure mechanism was temperature related in that the upper-most, hottest, coils were leaking crude oil into the convection bank space and igniting spontaneously despite the low stoichiometric availability of oxygen (normally 2-3%). In both heaters the coils had occasional bulges sometimes accompanied by a surface-breaking defect (figure 1). Both bulge and defect were exclusively located in the 12 o'clock position indicating local overheating and creep on the uppermost side in the direction towards the oncoming flow of hot flue gas stream. In refinery "A" the crown of one bulged tube was perforated by a 3 mm diameter hole through which the crude oil leaked. In refinery "B" the furnace coils experienced a generalized bulging throughout the uppermost shock tubes and in two cases the bulges had cracked releasing crude oil into the flue gas stream where it combusted. In refinery "B" insufficient oxygen was present to enable complete combustion and a mound of half burnt residue covered the respective pipes (figure 2).

Figure 1: Macro-aspect of crack in bulged convection section pipe (Refinery "B")

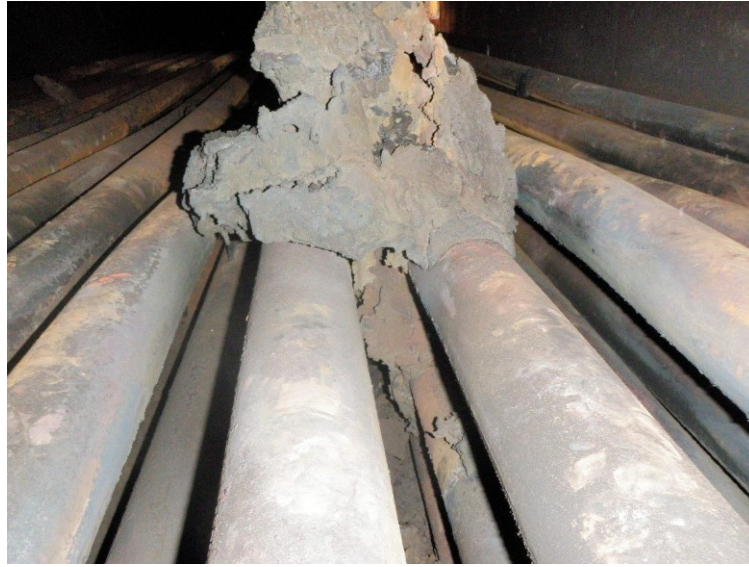
Figure 2: Burst convection section (shock tube) pipe in 12 o'clock position with burnt residue covering the rupture

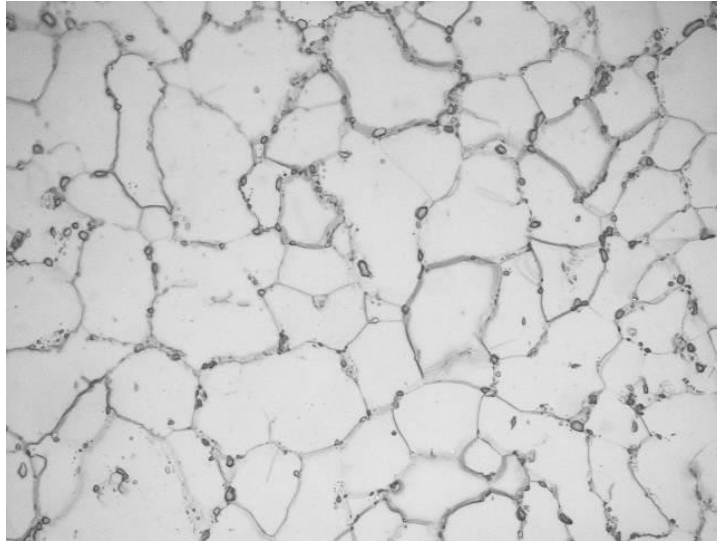
In both refineries the locally bulged pipes were examined metallographically and the normal expected ferrite-pearlite microstructure was substantially modified. Whereas in the normal as-received state A 106 Gr.B seamless pipe has a relatively moderate carbon content (table 1) the usual distribution of cementite was absent indicating spheroidizing in some cases or indeed complete graphitization (figure 3). Further evidence for severe overheating was provided by the thick layer of external oxide formed in both heaters (figure 4). Microhardness testing on both refineries showed the expected reduction to values around 120 HV at the 12 o'clock position while 160 HV was found at the 6 o'clock position associated with the "normal" microstructure. In some cases in refinery "A" some recrystallisation was visible at the prior austenitic grain boundaries indicating short term temperature above 723 C. These microstructures combined with the swelling and bulged geometry are clear indications of tertiary creep and expected failure within 1000-5000 hours.

Figure 3: Complete graphitization from normal ferrite-pearlite structure due to local overheating in 12 o'clock position

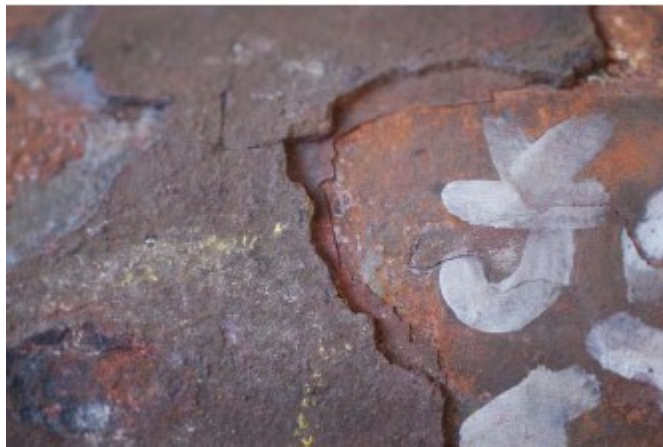
Figure 4: Thick oxide scale on outside of pipes of both refinery convection sections indicating overheating.

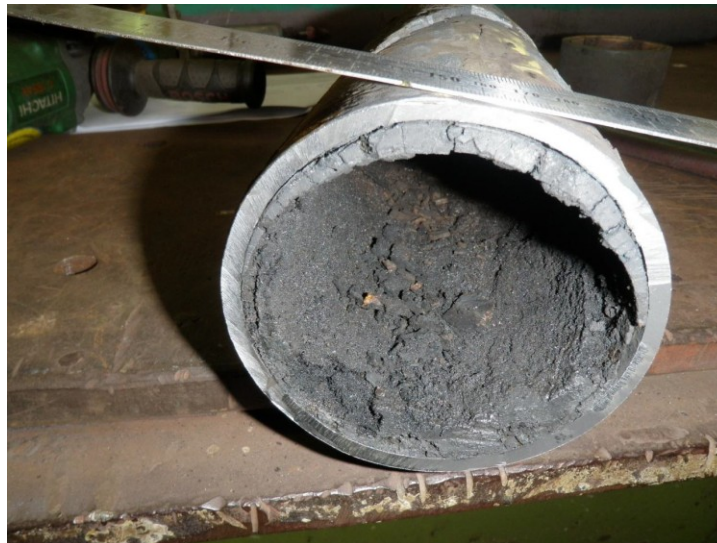
Identification of the source of the high temperatures for pipes which are normally considered to be internally cooled by the passage of warm (250 C) crude was associated with the general deposition in both refineries of a coke layer on the inner crown of the pipes. In the case of refinery "A" this coke layer reached 4 mm thick while in refinery "B" the maximum observed was 15 mm thick (figure 5). The refining industry at large has for several years used the general rule that for every 1 mm of coke build up the furnace skin temperature increases by 50 C above that of the outlet temperature. Hence for an expected 300 C crude outlet the refineries "A" and "B" had theoretical skin temperatures of 550 C and 1050 C.

Figure 5: Extensive internal coking in 12 o'clock position (highest heat flux)

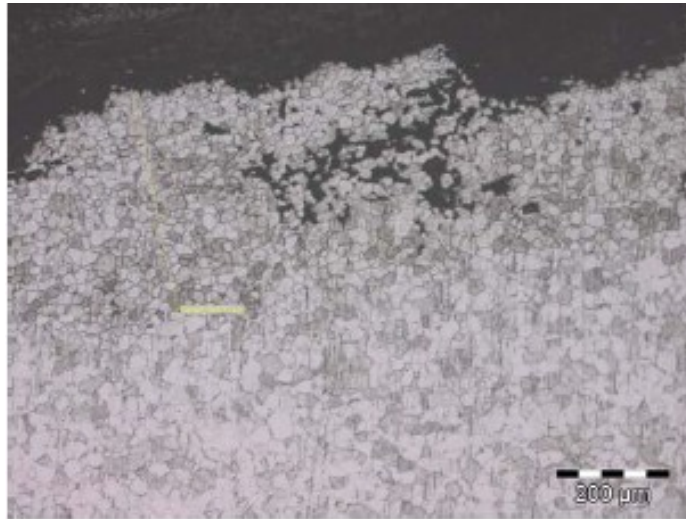
In addition to the evidence of creep associated with the macro-bulging another mechanism was present in both refineries. While bulging and microstructural decomposition due to high temperatures was in evidence, the internal 12 o'clock position in both heaters was also characterised by graphite deposition at the grain boundaries forcing the grains apart and causing a general wall loss by flaking off of grain layers (figure 6). In the case of refinery "A" this deposition not only extensively penetrated the boundaries but also took the form of internally grown large graphite nodules which appeared to displace the surrounding steel grains and their physical deformation (figure 7). This mechanism has been tentatively identified as *Metal Dusting*, a process resulting from extremely high local temperatures and a high carbon activity (ac) resulting from thermal cracking of available hydrocarbons. Refinery "A" estimate that the process occurred in the region 560-620 C. In refinery "B" skin temperatures were eventually measured by thermocouple to exceed 650 C for long periods of time without the expected damage by more conventional mechanisms (creep).

Figure 6: Carburation of internal surface pipes in both refineries

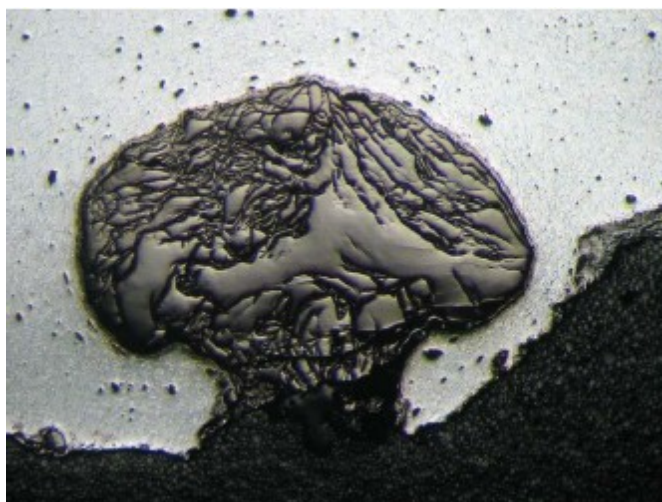
Figure 7: Internal growth of graphite nodules in refinery "A"
